## ADDITIVE "BLOOM" ON TIRES

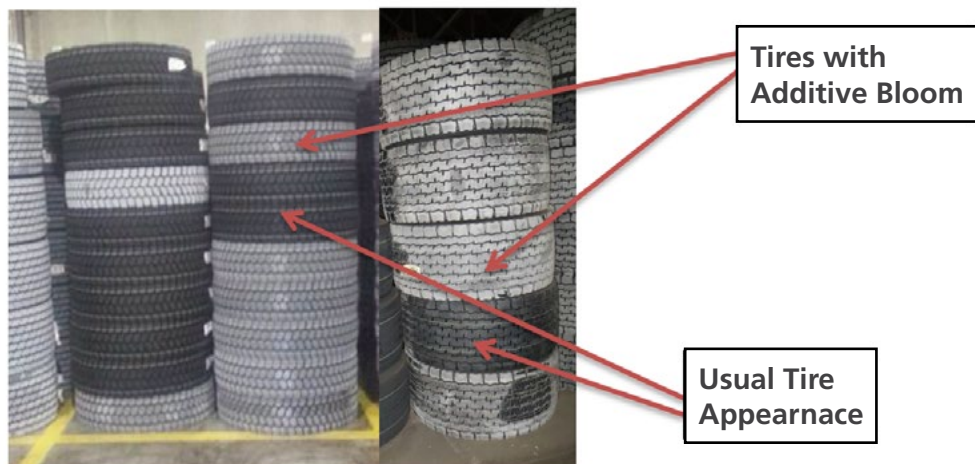
The purpose of this communication is to explain the presence of a milky white discoloration, also known as Additive Bloom, on the surface of certain Michelin tires and treads. This bloom may be seen on tires during cold weather. **The presence of this bloom on the surface of the tread rubber has no impact on the safety or performance of the tire, and presents no hazard during handling of the tire.**

The bloom is a mixture of waxes and other additives used to provide tires with protection against oxidation and ozone degradation and to aid in tire production. The waxes and additives have the ability to migrate to the surface of the tire and back into the cured tire during usage and heating cycles.

The bloomed appearance will diminish when tires are placed in service, as the bloom will wear off the tread surface, and heat generated during the use of the tire will cause bloomed materials to migrate back inside the tire. Washing of the tires or contact with water will wash off water-soluble bloomed materials.
