Sacrificial Rib / Decoupling Groove Damages

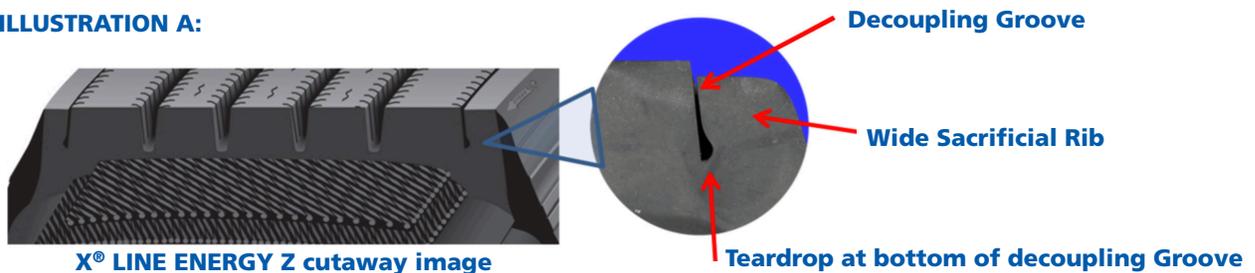
ILLUSTRATION A:

The MICHELIN® X® Line Energy Z patented sacrificial rib design provides irregular wear protection to the shoulder ribs. It is also engineered to be more robust in preventing tearing at the groove bottom. As shown in Illustration A, the width of the sacrificial rib grows wider towards the bottom, providing support to the tread rib under load, and helping to prevent the onset of irregular wear. The teardrop at the bottom of the decoupling groove helps prevent tearing in the groove from potential over flexing.

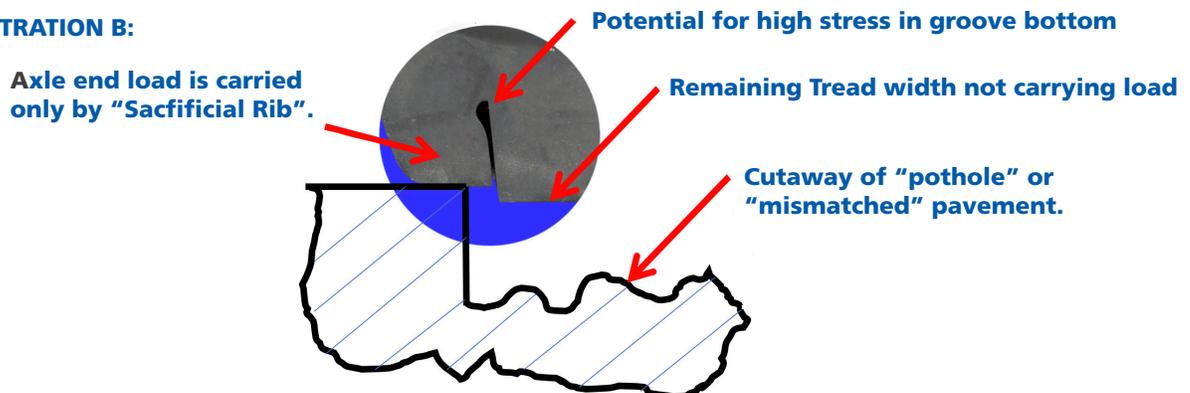
ILLUSTRATION B:

While the Sacrificial Rib / Decoupling Groove feature serves an important purpose in extending tire tread life, it can be susceptible to potential damages. One area of concern is zero-speed turning (i.e. turning the vehicle's steering wheel when the vehicle is not in motion), as it can cause tearing of the sacrificial rib or splitting in the decoupling groove. Over flexing of the sacrificial rib may also cause damage during operation in more regional, high scrub applications. Damages can be caused by hazards such as mismatched drop off pavement, potholes, and curbs (see Illustration B). Operating at excessive temperature may also contribute to the damage.

Sacrificial rib tearing may be accompanied by micro sipe tearing or upper sidewall scrub as indicators of the root cause.

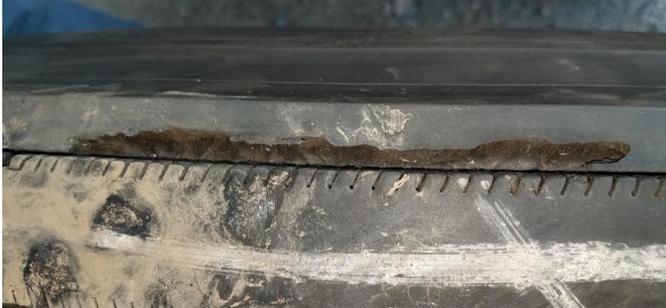
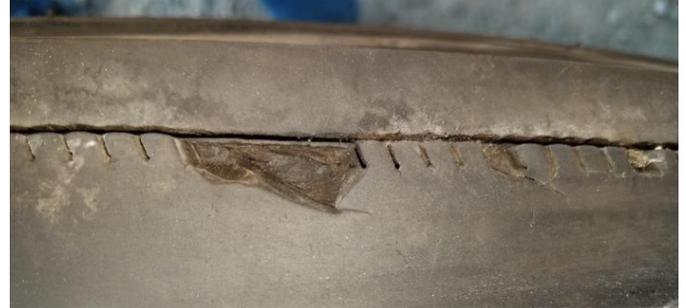
CLASS "A" Injuries to sacrificial rib or micro-siping with no decoupling groove splitting

- **Appearance:** chipping of rubber at edge of decoupling groove, missing micro-sipes, no splitting observed at bottom of the decoupling groove.
- **Action:** no need for removal, tire can remain in service.

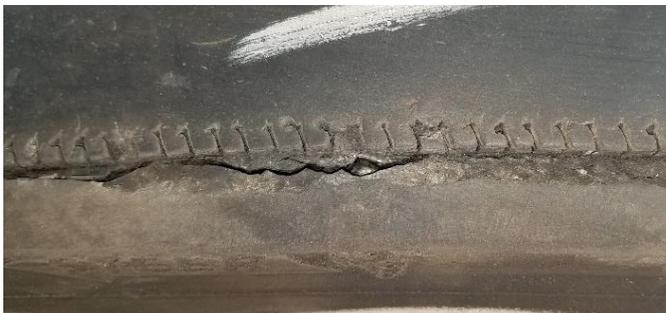
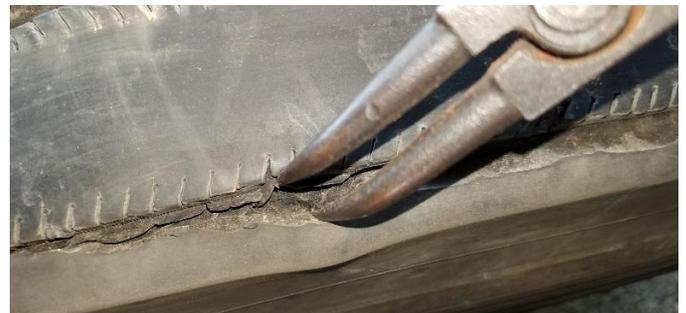
CLASS "B" Injuries to sacrificial rib or micro-siping with splitting of the decoupling groove

- **Appearance:** chipping of rubber at edge of decoupling groove, splitting deeper than 2mm observed at bottom of decoupling groove.
- **Action:** remove from service and process for possible retreading.

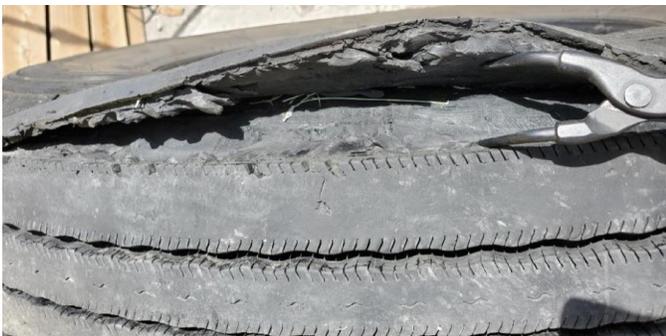
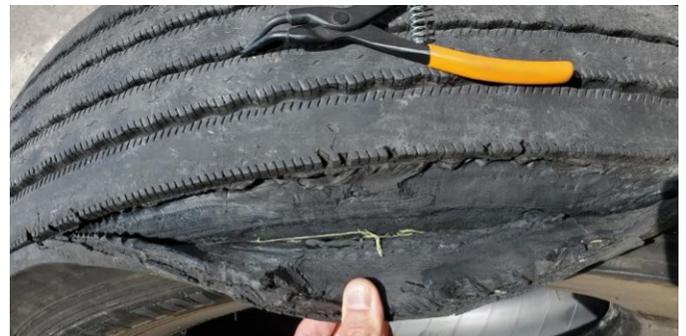
CLASS "C" Injuries to sacrificial rib or micro-siping with splitting and tearing of the decoupling groove

- **Appearance:** chipping of rubber at edge of decoupling groove, extensive splitting causing tearing and opening of sidewall rubber. This damage starts as a split in the decoupling groove and propagates down the sidewall.
- **Action:** Remove tire from service and dispose.
